Analytical Investigation of Damaged 320 Crankshaft

Lycoming 320 Engine

July 10, 2009

Crankshaft - P/N SL32500 - Serial Number TA07B-000430

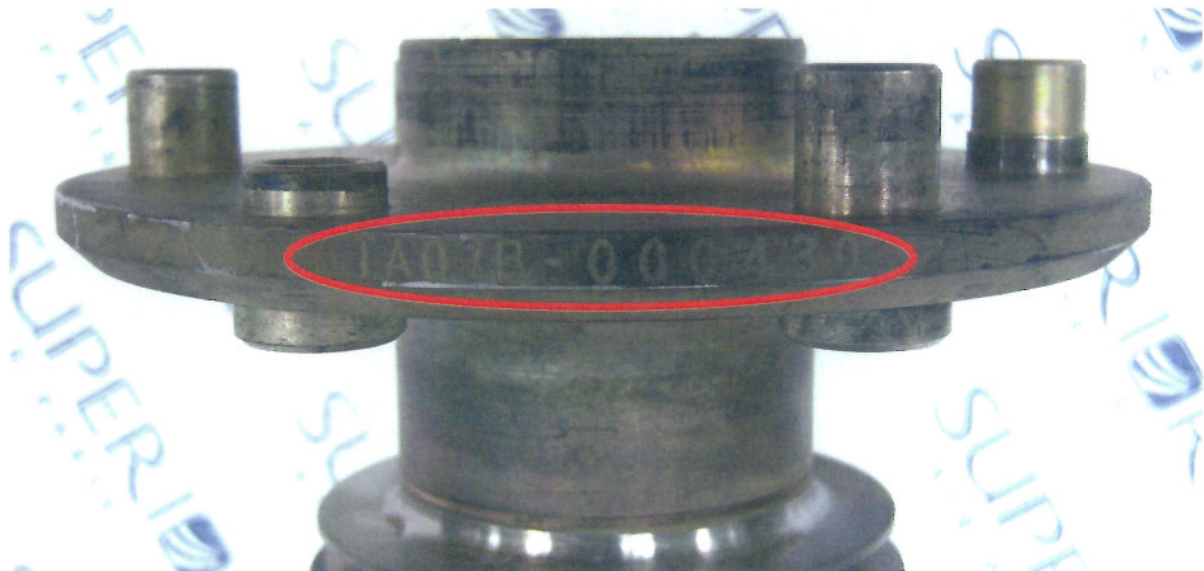
Part Number SL32500

Serial Number TA07B-000430

The crankshaft hardness was checked and found to be 87HR which is within manufacturers limits of 83HR15N minimum.
